Development of EMAT Sensors for Corrosion Mapping of UNGP Using ILI Tools

Project Final Report Public Version

December 2019

U.S. Department of Transportation
Pipeline and Hazardous Materials Safety Administration

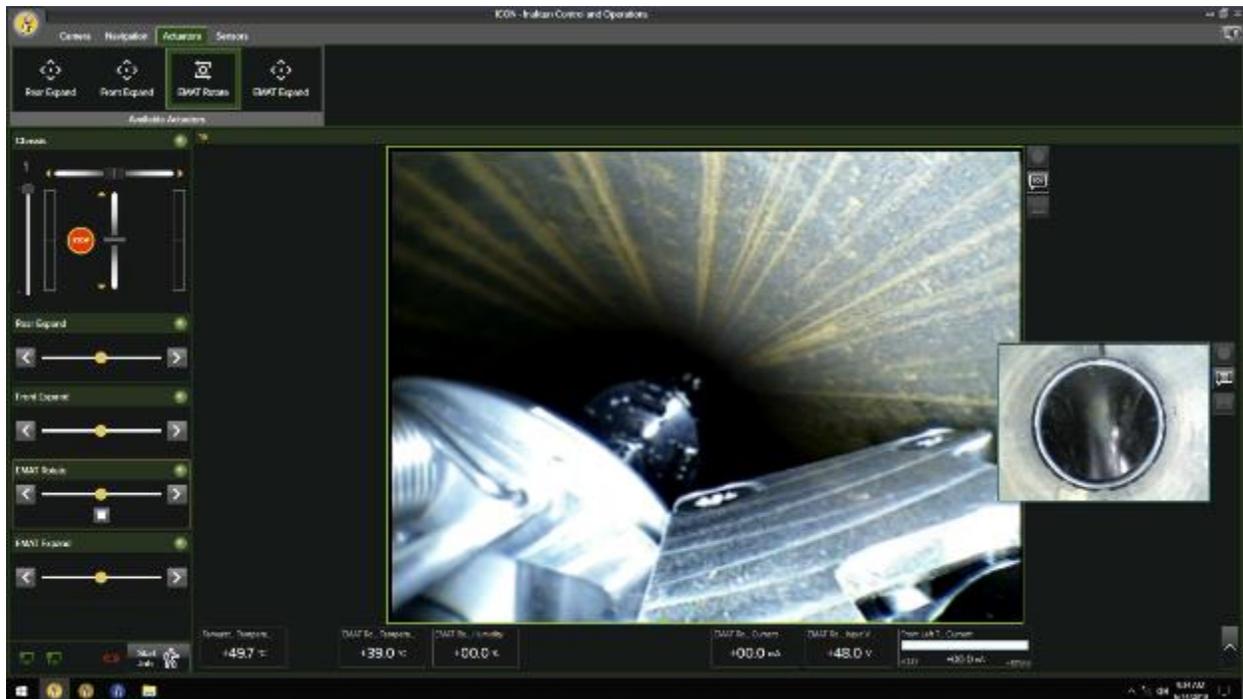
Figure 33. Base Station Graphic User Interface

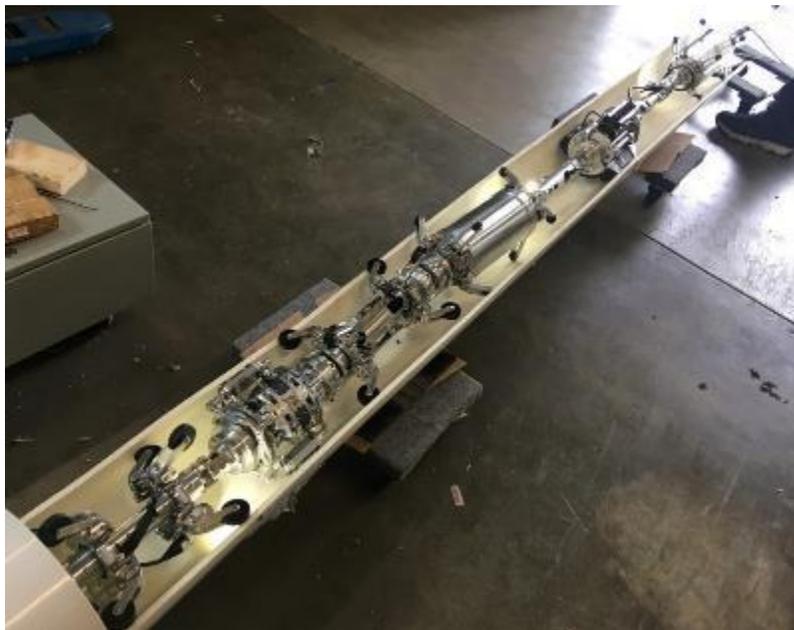
Figure 34. Integrated EMAT/WT Robotic System

Once the robotic platform arrived at Qi2, we reconnected the EMAT sensors and associated electronics with the rest of the system. An image of the integrated tool is shown in Figure 34. For testing, we used our 8" schedule 40 pipe section with nominal all thickness of 0.322" and artificial flaws (See Figure 11). After several small modifications and tests, the system went alive. A view of the base station computer showing the sensors inside the pipe as well as live EMAT signals are shown in Figure 35. A detailed view of the gathered acoustic responses (multiple echoes) for both sensors are presented in Figure 36.

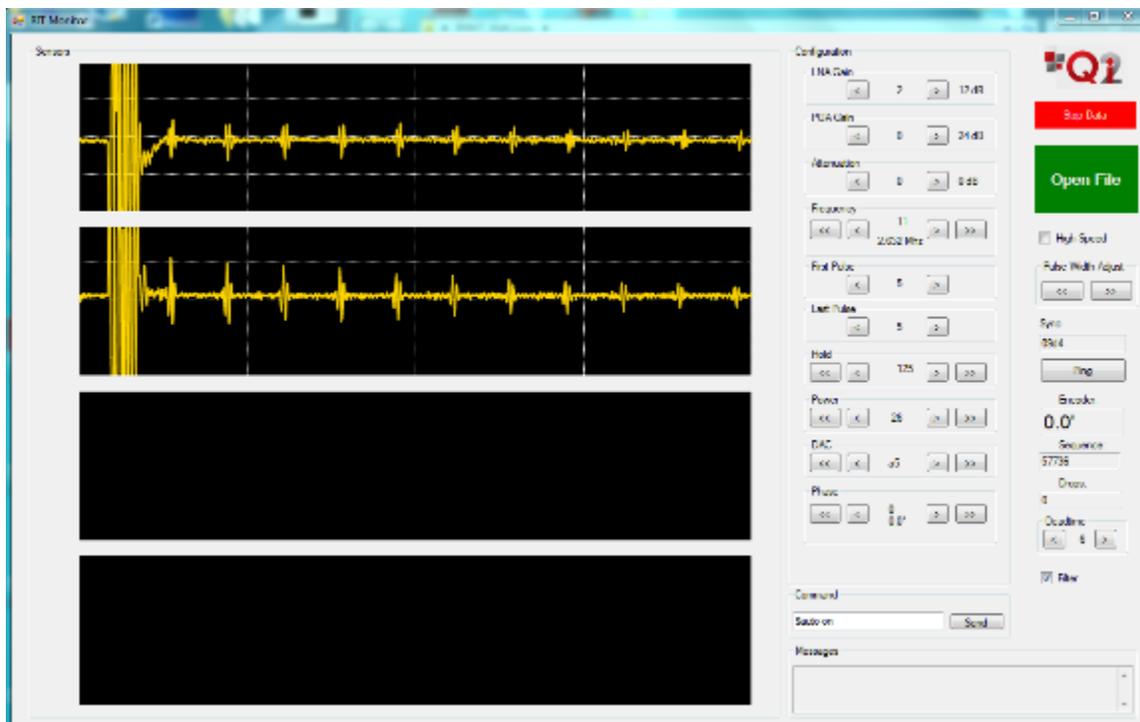
Figure 36. EMAT/WT Signals from the System

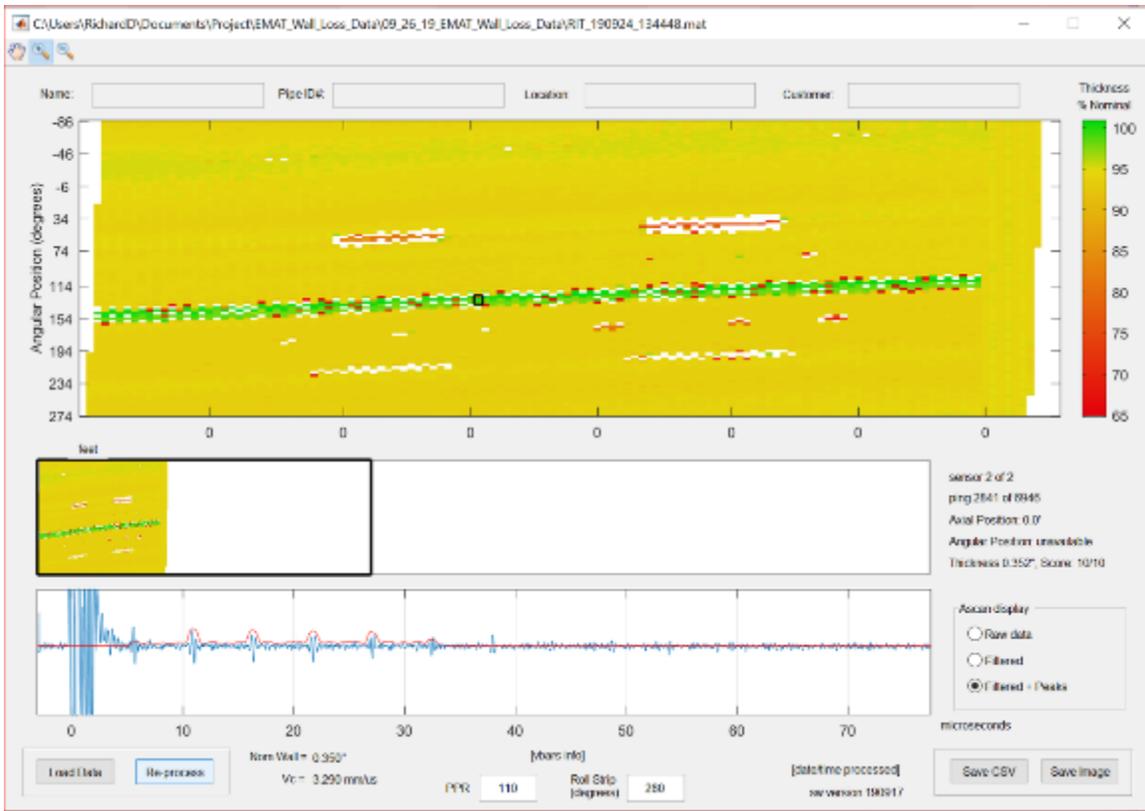
Figure 37. EMAT C-Scan using One Cycle at 2 RPM

The pipe was scanned using different settings to assess difference in behavior and C-Scans were produced as the one shown in Figure 37. In this figure can be observed that the flaws were clearly identified and thanks to the high resolution of our EMAT sensors, measurements were taken on those flaws. It is important to note that the flaws in the test sample were created using a ball end mill or milled flat (tangent). This means that in both cases there is only a single axial line where the tangent of the flaw is parallel to the inner surface of the pipe. This is the most critical test. Most wall loss test samples are created by machining the bottom of the flaws parallel to the inside surface for at least the length of the sensor resolution making the flaws easier to characterize. The long diagonal "green" line along the C-Scan is the ERW line. It is important to note that two narrow EDM notches, to simulate cracks, were present on the sample. These flaws were also detected as long and narrow bands below the square and round flaws

The C-scan plot represents a solid and successful integration between the EMAT sensors, EMAT electronics, the robotic platform as well as the communication along the system and processing of the signal. The high resolution of the 1/4" measurement foot-print EMAT sensor was clearly demonstrated.

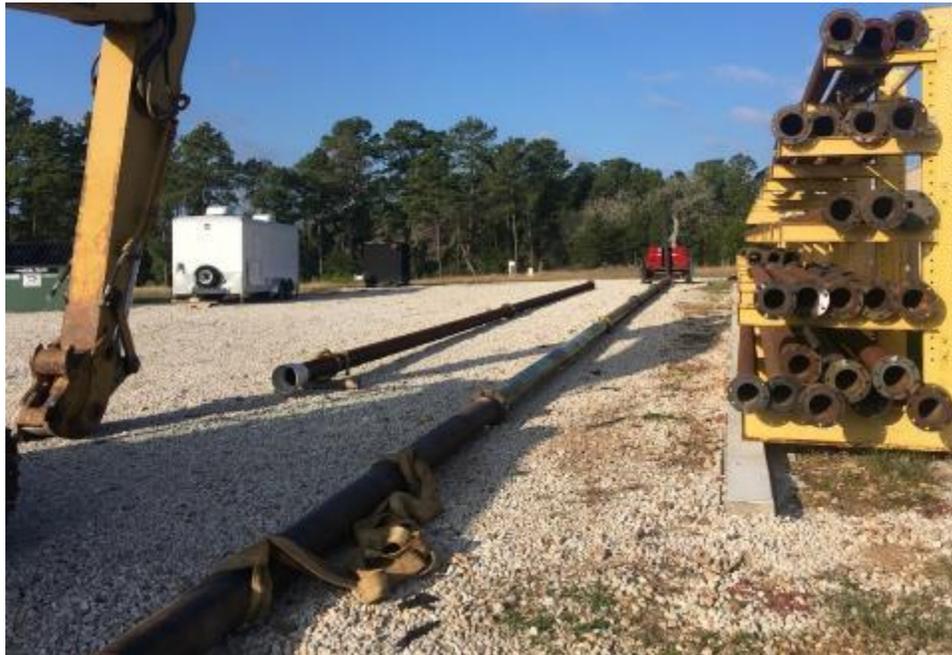
Figure 40. Piping Setup 1

A piping setup was assembled with six 8" diameter pipe segments. The segments were attached using bolted flanges with a total length of 116ft. Figures 40 and 41 show the setup and a sketch of the pipe configurations respectively. Two X42 pipes with different schedules and machined metal loss flaw were placed in positions 4 (Sch 40) and 5 (Sch 20). These pipes are normally used by Q-Inline for MFL testing. It is important to note that these flaws have rounded edges as can be observed in Figure 42. A cleaning pig was run through the line to ensure it was free of any debris that could damage the tool.

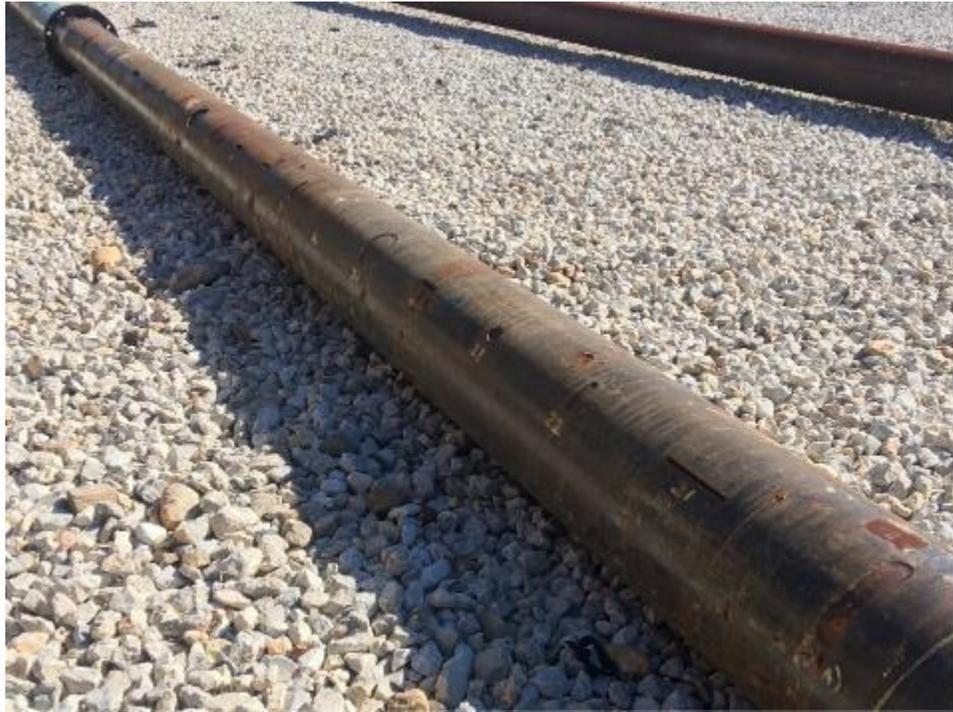
Figure 42. Detailed view of Pipe with Metal Loss Flaws on Setup 1

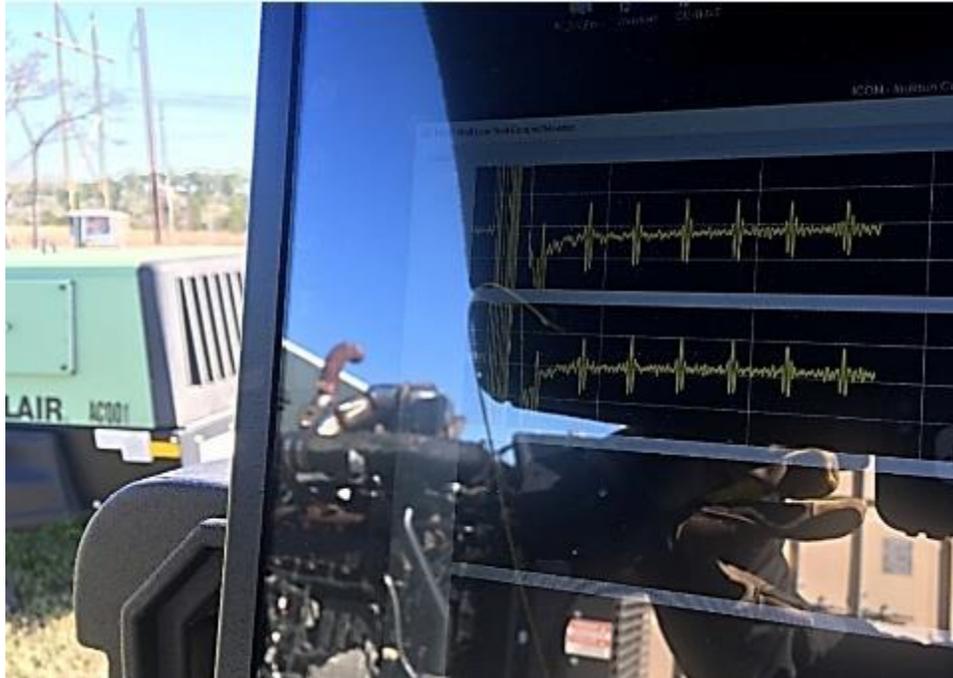
Figure 44. EMAT/WT Ultrasonic A-Scan Responses During Inspection on Setup 1

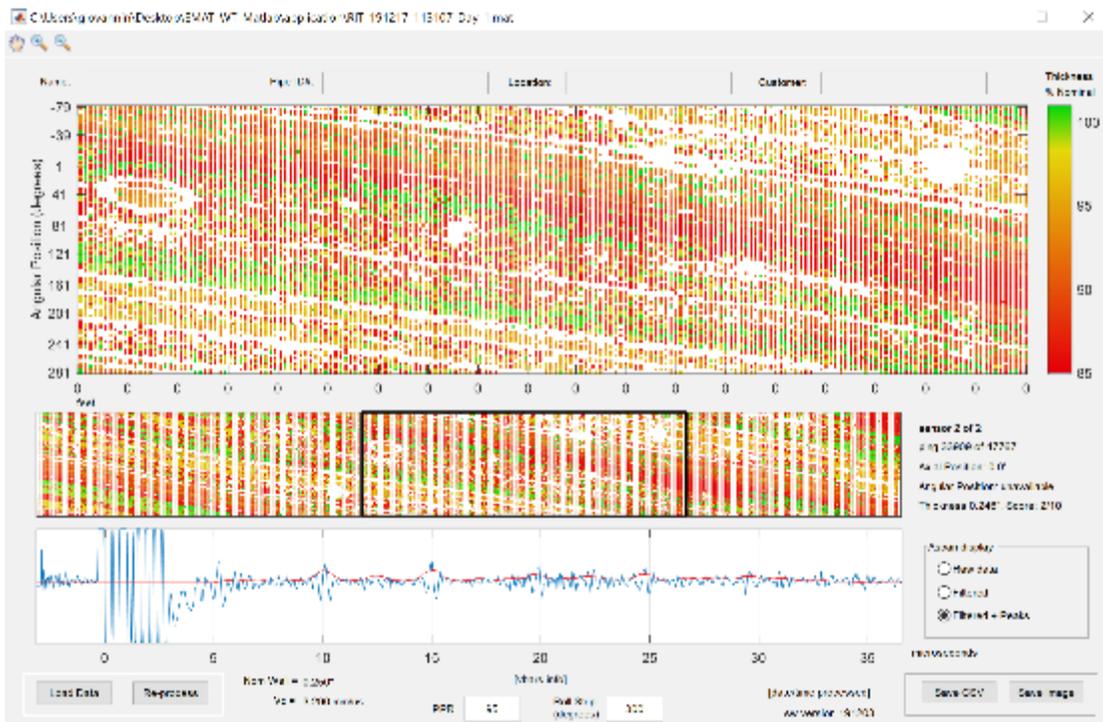
Figure 46. EMAT C-Scan for Pipe in Setup 1 at 31 RPM

A PVC "launcher" and a 10"-8" PVC reducer were mounted at one end of the setup as an insertion bed for the robot (Figure 43). The EMAT/WT system was powered up and the crawler navigated through the pipes 1-3 with the scanning mechanism retracted. Once the tool reached pipe 4 (i.e. first metal loss pipe), the scanning mechanism was extended and rotated at 31 RPM to collect wall thickness data. Live signals from the sensors are shown in Figure 44. After scanning the pipe for ~ 6ft, unfortunately one of the EMAT signals was lost, as a result, the inspection was stopped. The tool was extracted from the pipe for further assessment. It was found that one of the wear pads was damaged probably during tool navigation. The second wear pad was found ok. The data was processed and produced a C-Scan of the inspected pipe section as shown in Figure 46. It can be observed that the tested pipe has a wide variation on wall thickness. Q-Inline indicated that the pipes, at position 4 and 5, were very noisy due to very poor manufacturing quality. Nevertheless, the EMAT/WT was able to measure wall thicknesses on many places on the pipe including on the bottom of some medium/large machined metal loss flaws. The system was also able to provide a picture of the shapes of those flaws.

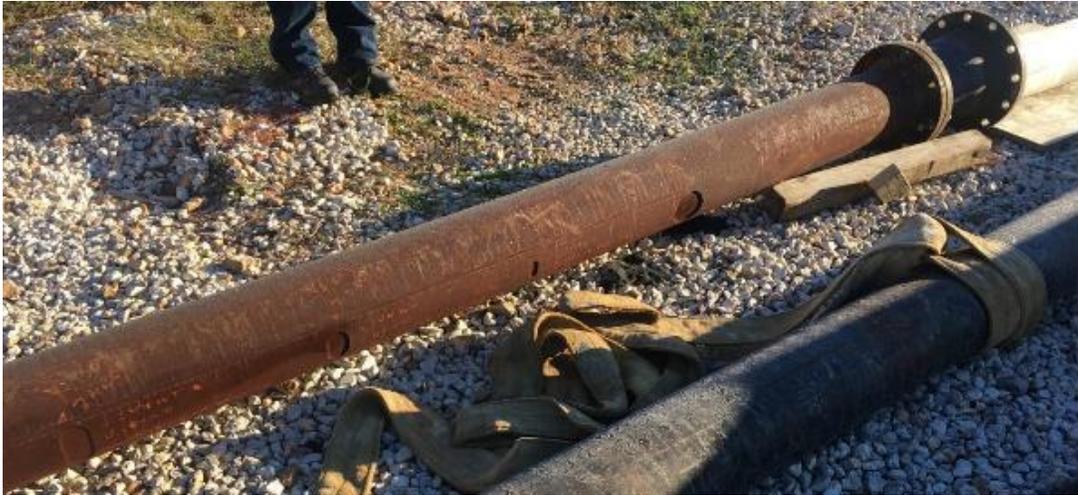
Figure 48. Detailed view of Pipe with Metal Loss Flaws on Setup 2

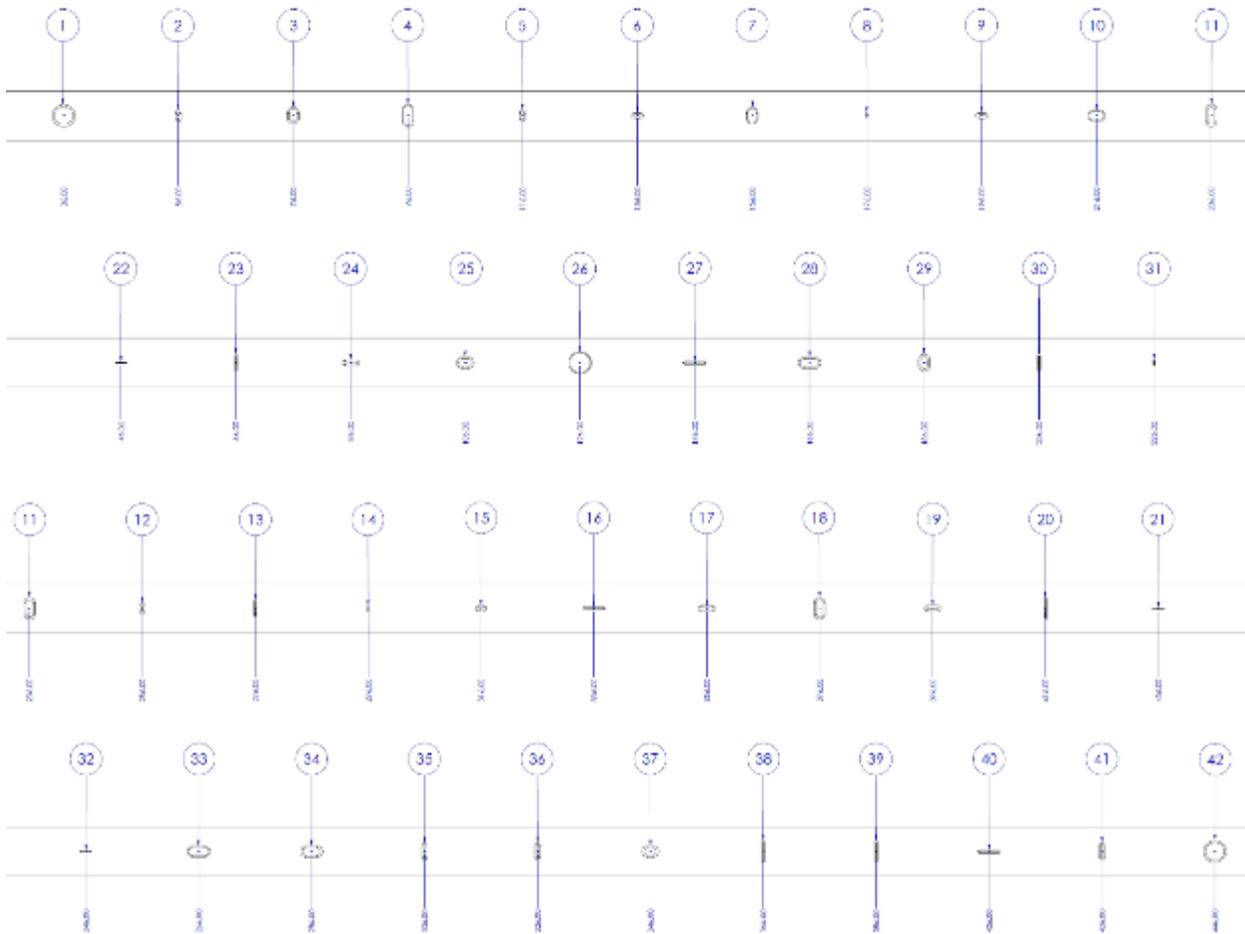
Figure 49. Metal Loss Flaw Map for Pipe on Setup 2

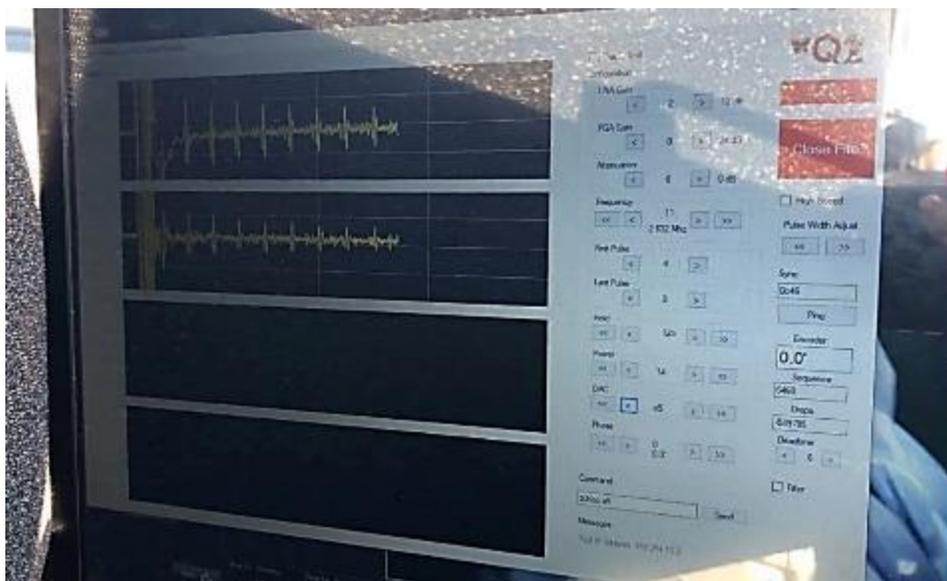
Figure 51. EMAT/WT Ultrasonic Responses During Inspection on Setup 2

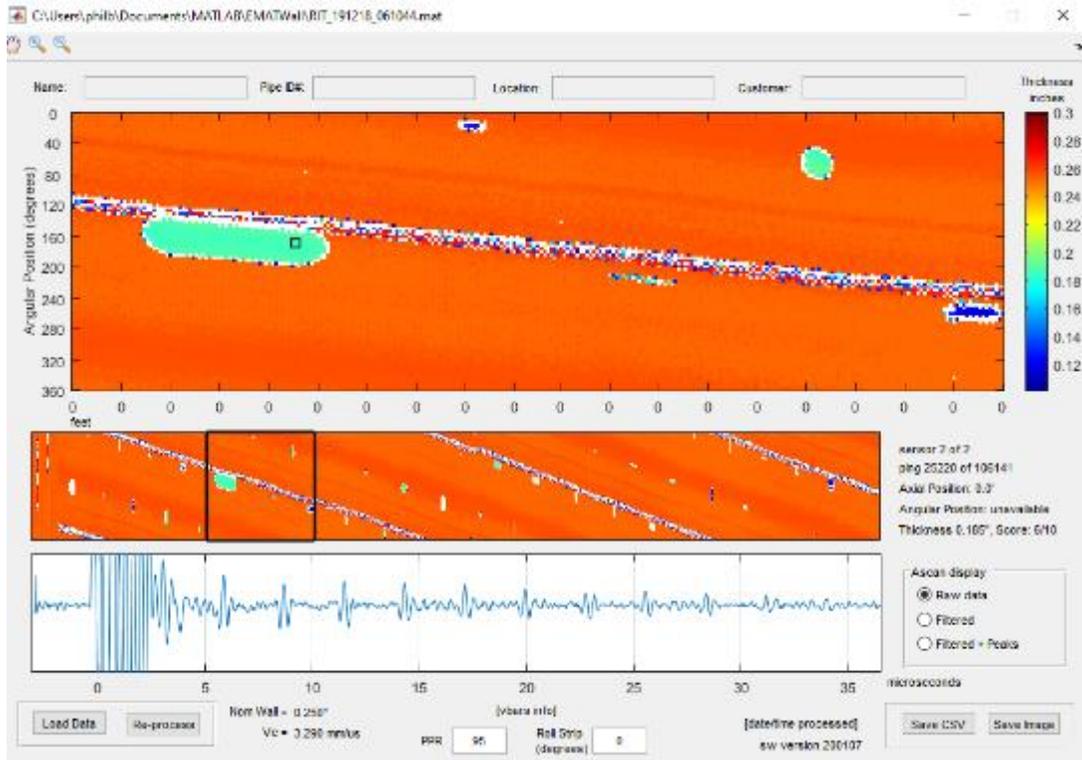
Figure 55. EMAT C-Scan for Pipe in Setup 2 on Forward Direction at 31 RPM

After replacing the broken wear pad, a different piping setup was used to avoid any further damage on the pads. An X42 8" diameter pipe with a total length of 42.9ft and schedule 20 was selected. The tool was guided into the pipe using a 10"-8" steel reducer (Figure 47). Some metal loss flaws on the pipe can be observed in Figure 48 with a detailed flaw map depicted in Figure 49 and specs in Table1. The EMAT/WT robot was inserted into the pipe (Figure 50) to perform an EMAT inspection with live signals shown in Figure 51. Some views of the robot inside the pipe as well as the other end of the pipe are shown in Figures 52 and 53 respectively. Once the scan was completed in the *forward* direction, the robot crawled back collecting data again (*backward* direction), and it was removed from the pipe. The wear pads were inspected and found functional without any apparent damage. C-Scans were produced for both scanning directions and are presented in Figure 55 for forward and Figure 56 for backward directions. On the forward C-Scan, we can observe that the EMAT/WT scanner was able to detect 40 of the 42 flaws! The 2 missed flaws were probably too narrow for the sensor to be detected. On the backward C-Scan, of Figure 56, can be noted that the data is a bit noisier than on the forward C-Scan (Figure 55). This was due to an accidental increase in axial velocity of the robot during scanning. In spite of that incident, the superior quality of the pipe in Setup 2, in comparison with those used on Setup1, is evident in both C-Scans. Furthermore, the flaw shapes are almost well-defined in most of the cases due to acoustic signal losses on their rounded edges. Finally, the system was able to get wall thickness measurements at the bottom of some flaws for the given radial and axial scanning speeds. It is clear that a more detailed C-Scan of the pipe can be obtained by reducing the scanning speed.

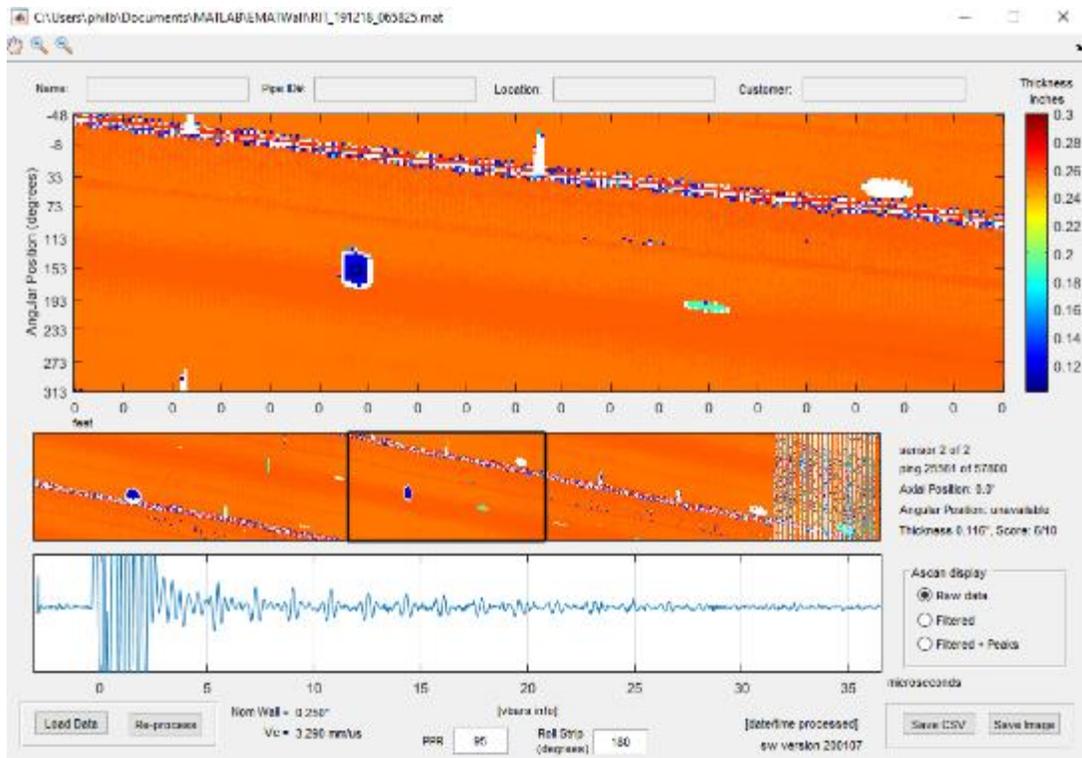
Figure 56. EMAT C-Scan for Pipe in Setup 2 on Backward Direction at 31 RPM

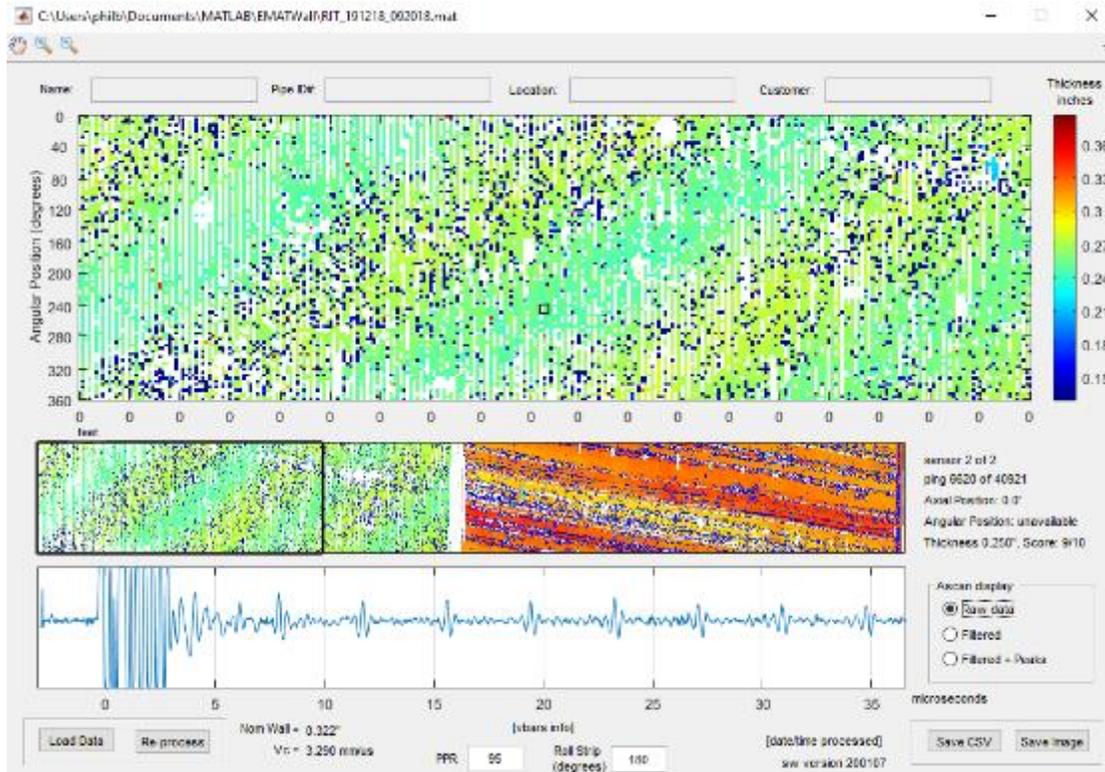
Figure 60. EMAT C-Scan for Pipe in Setup 3 on Forward Direction at 31 RPM

Based on the field-test results, it is clear that the system still needs some further refinements. Sensor wear pads will be upgraded to ceramic-based ones to increase their durability. The EMAT sensor carrier needs to be fine tuned to improve the transition between pipes as a result, wear pad durability will increase. Regarding sensor performance, noise produced by the electrical motors of the scanning mechanisms need to be minimized. This will improve the signal-to-noise ratio of the EMAT sensors considerably and should significantly increase the amount of good C-Scan data in the noisy pipe sections, Figures 60 through 62 and marginal areas in Figures 55 and 56.

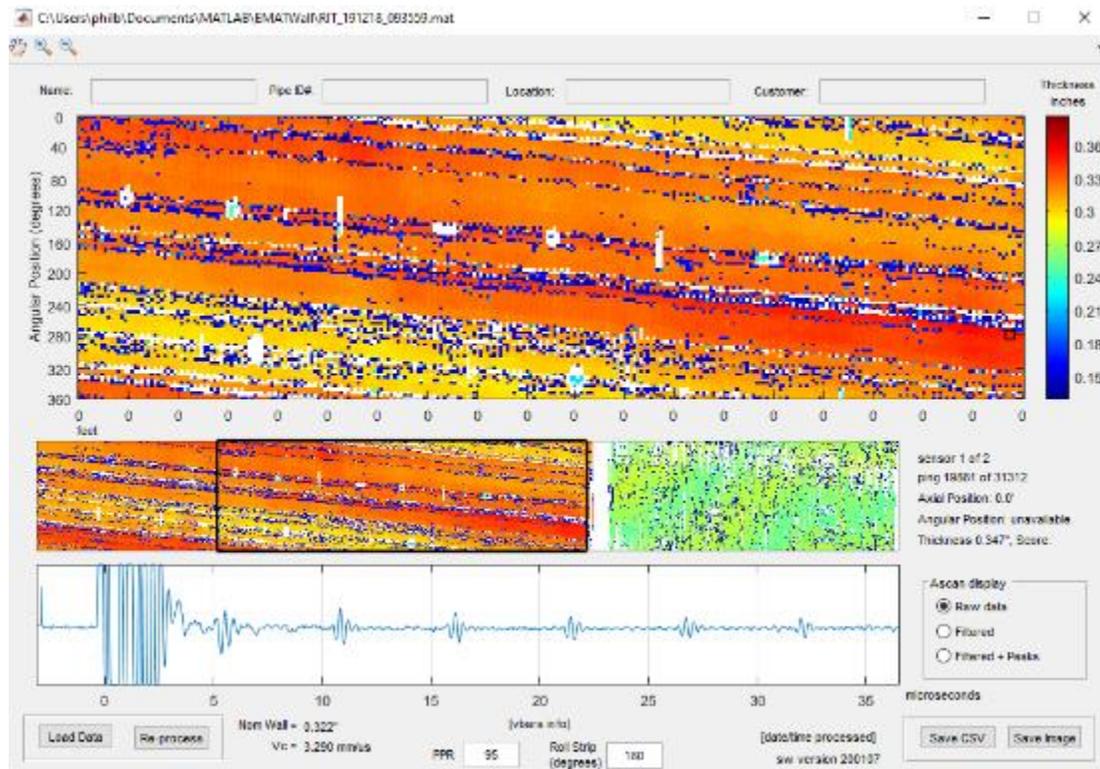
Figure 61. EMAT C-Scan for Pipe in Setup 3 on Backward Direction at 31 RPM

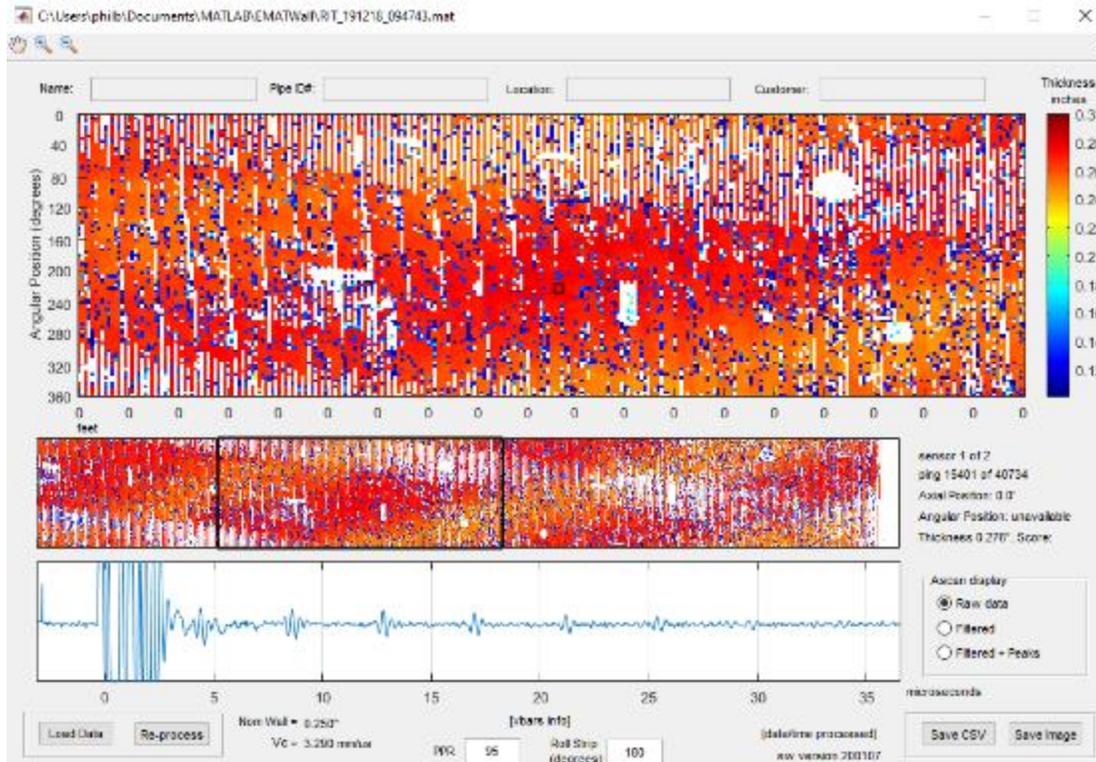
Figure 62. EMAT C-Scan on Last Section for Pipe in Setup 2 on Backward Direction at 31 RPM
